Lessons from the Ashes: Improving Transportation Safety Through Accident Investigation

2019 Westminster Lecture on Transport Safety

Robert Sumwalt, FRAeS

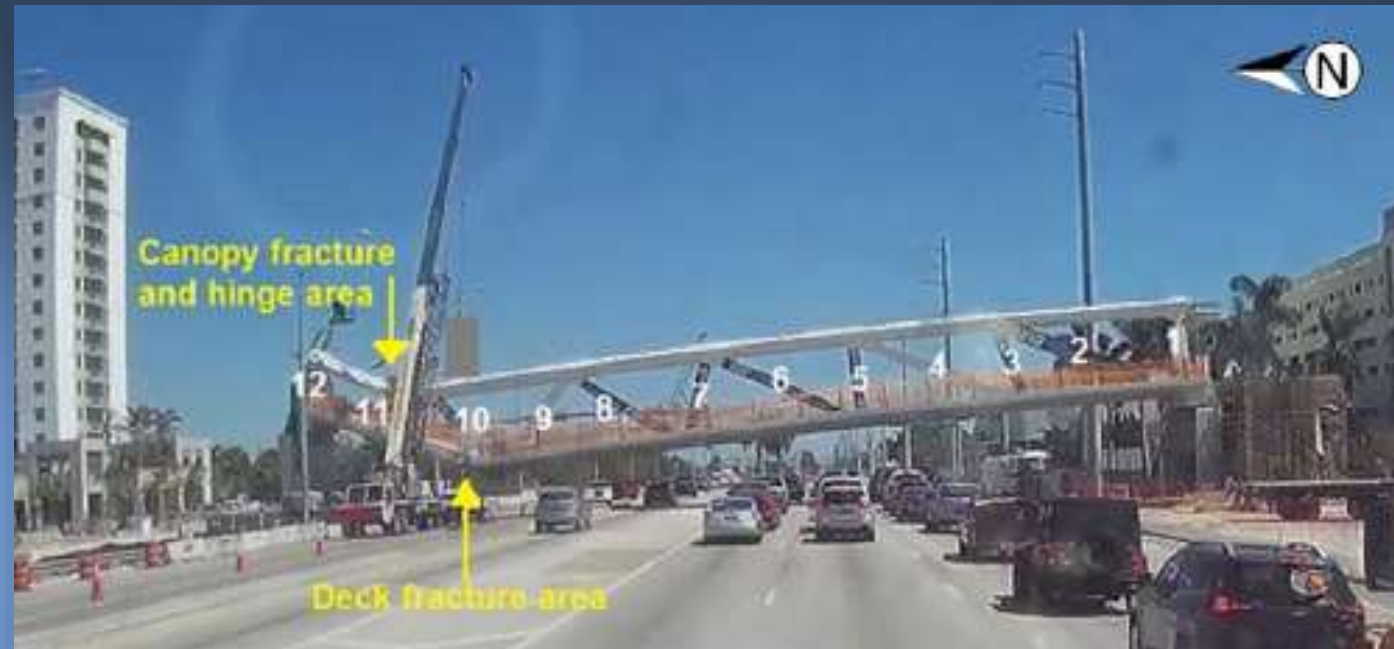
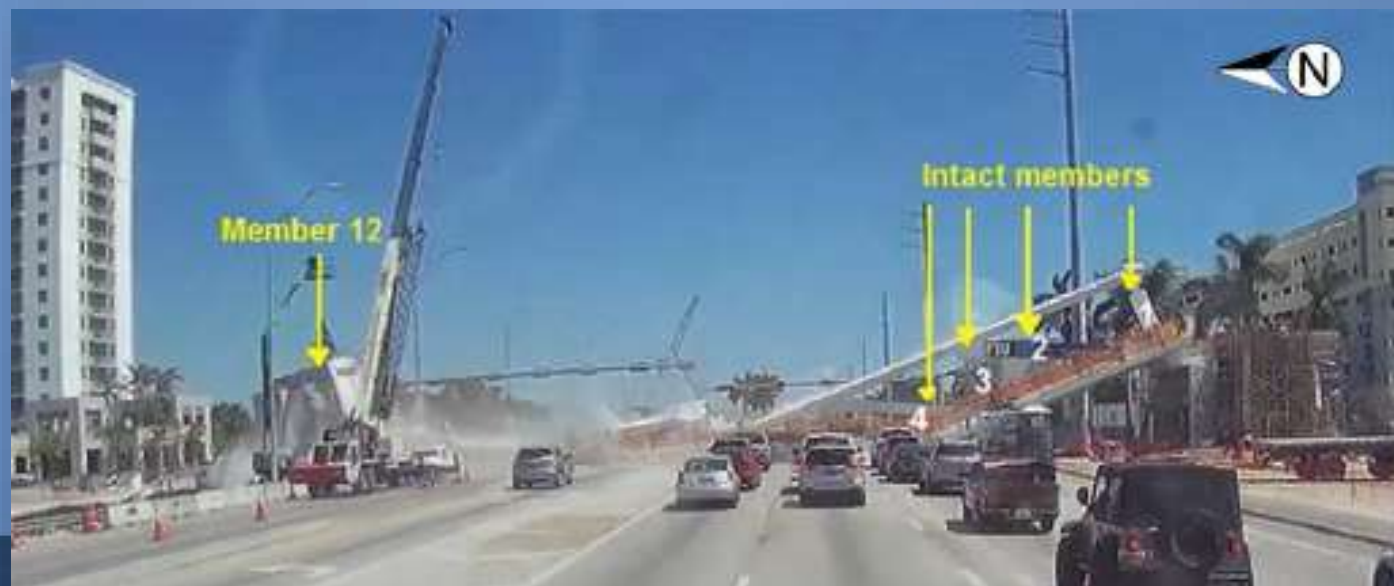
Facing East

Magnitude of
horizontal force –
60 percent larger
than vertical force

- Bridge was under-designed
- Peer review was insufficient
- Failure to close bridge to traffic and workers

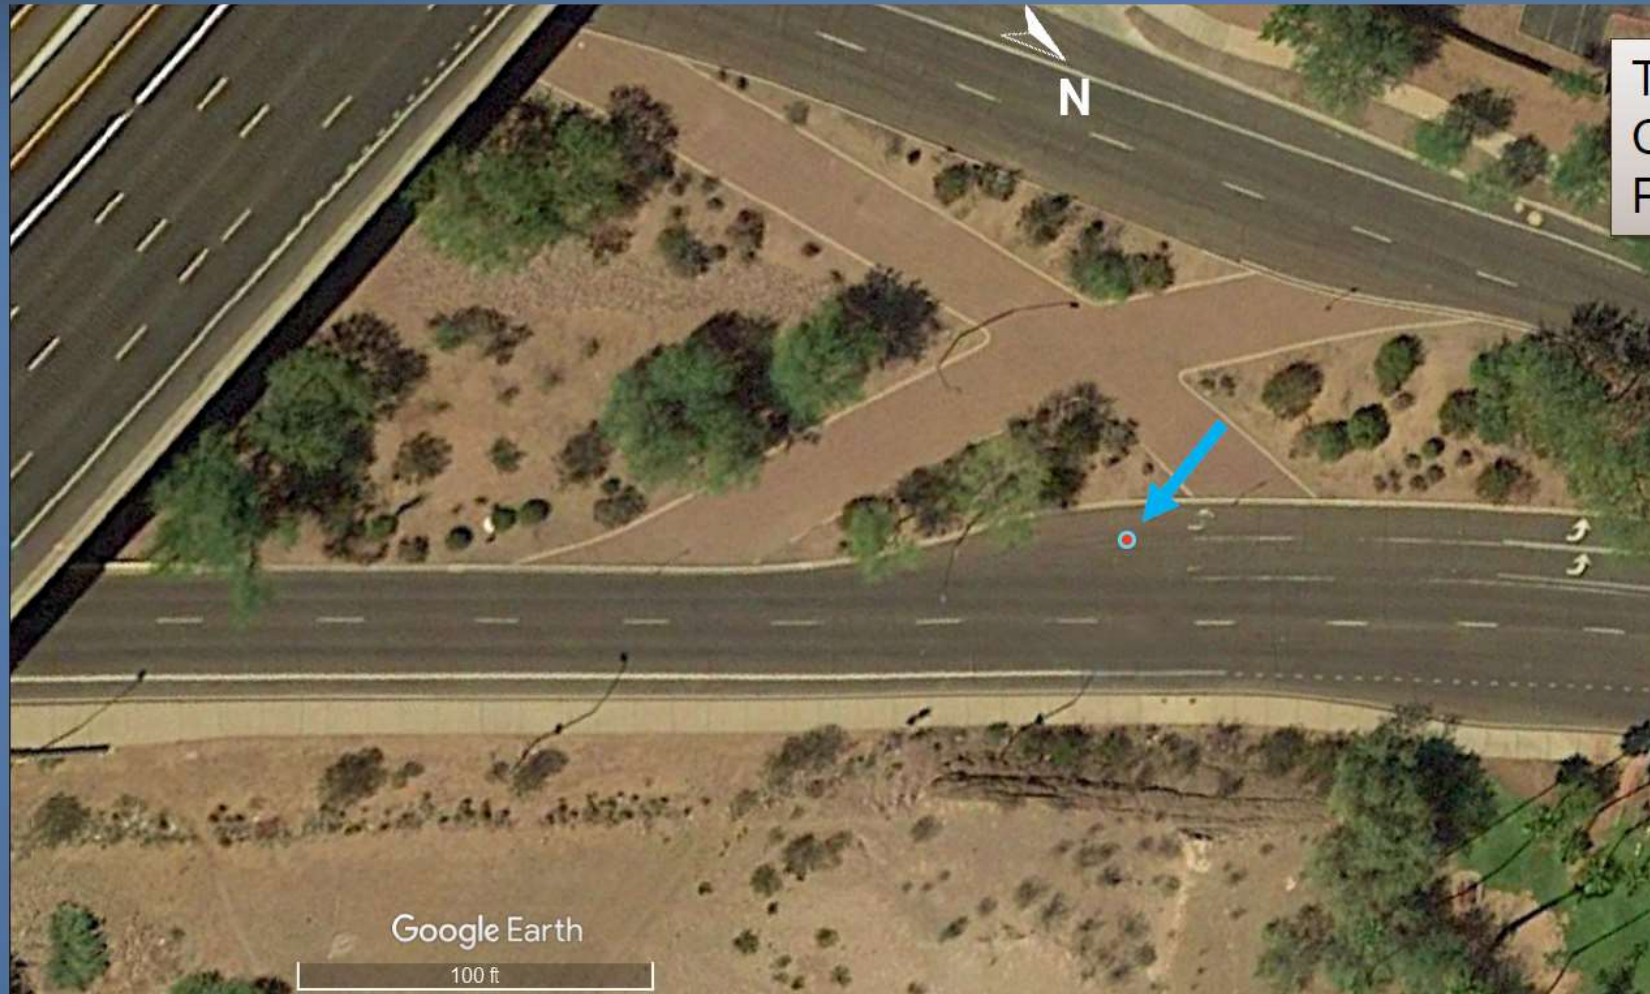
Perception and Motion During the Crash

Time to crash:	5.6 seconds
Classification:	Vehicle
Predicted path:	None

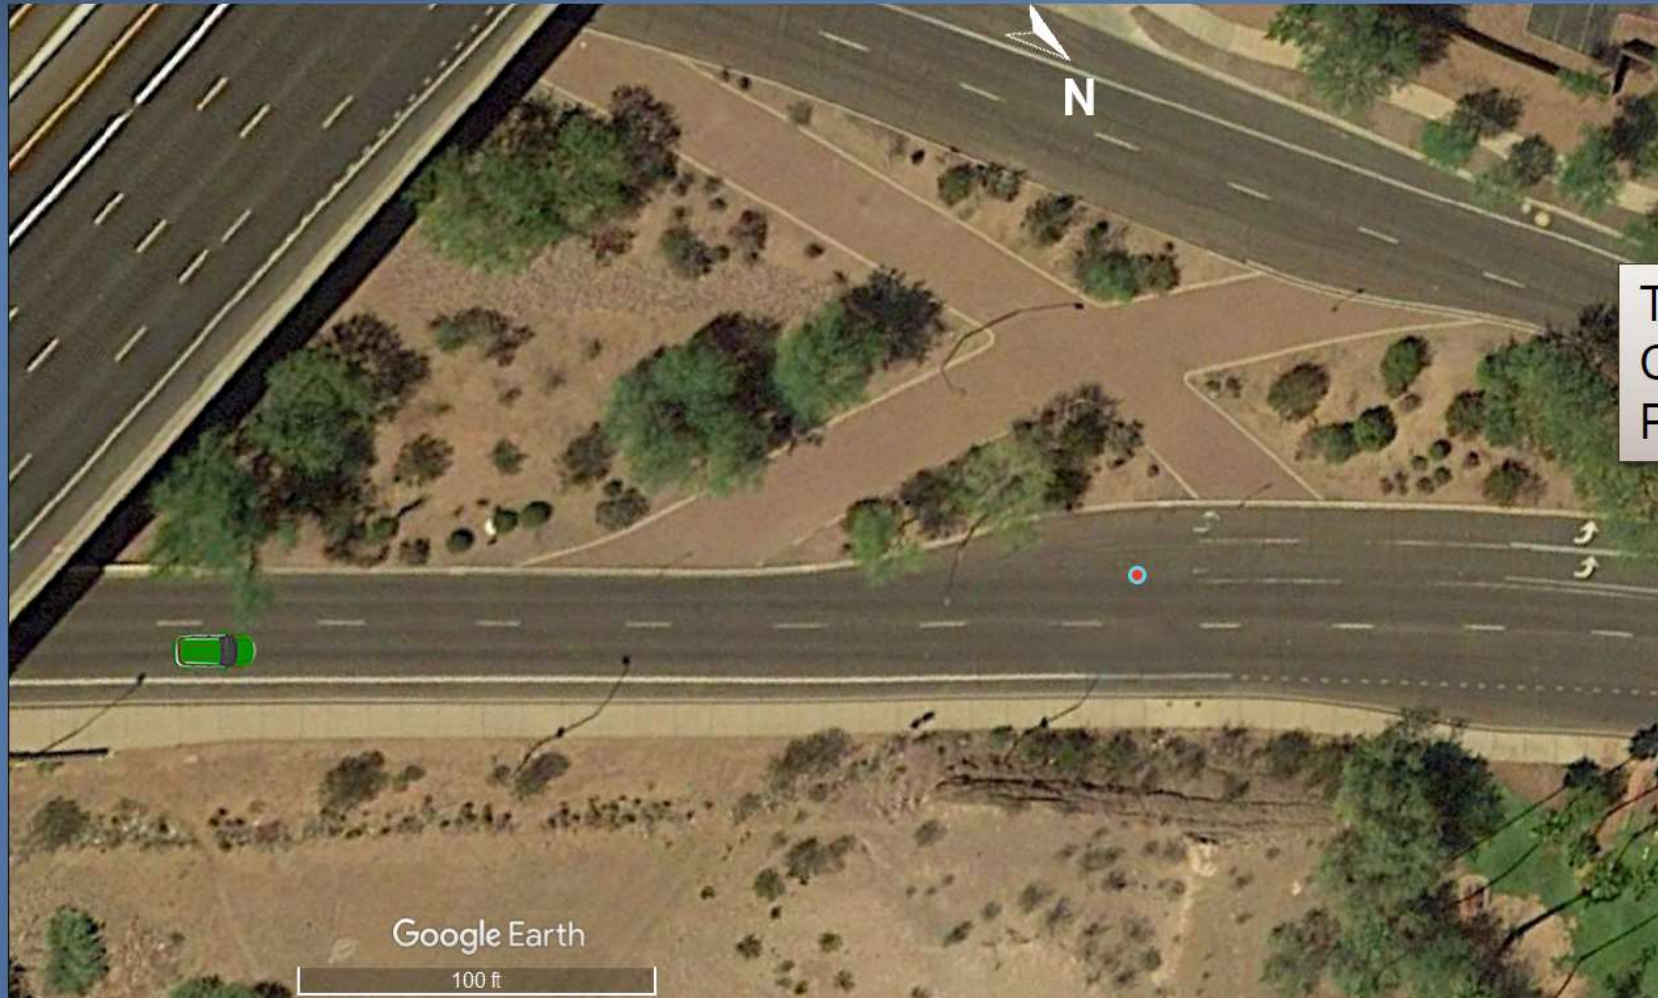
Perception and Motion During the Crash

Time to crash: 3.9 seconds
Classification: Vehicle
Predicted path: Left lane

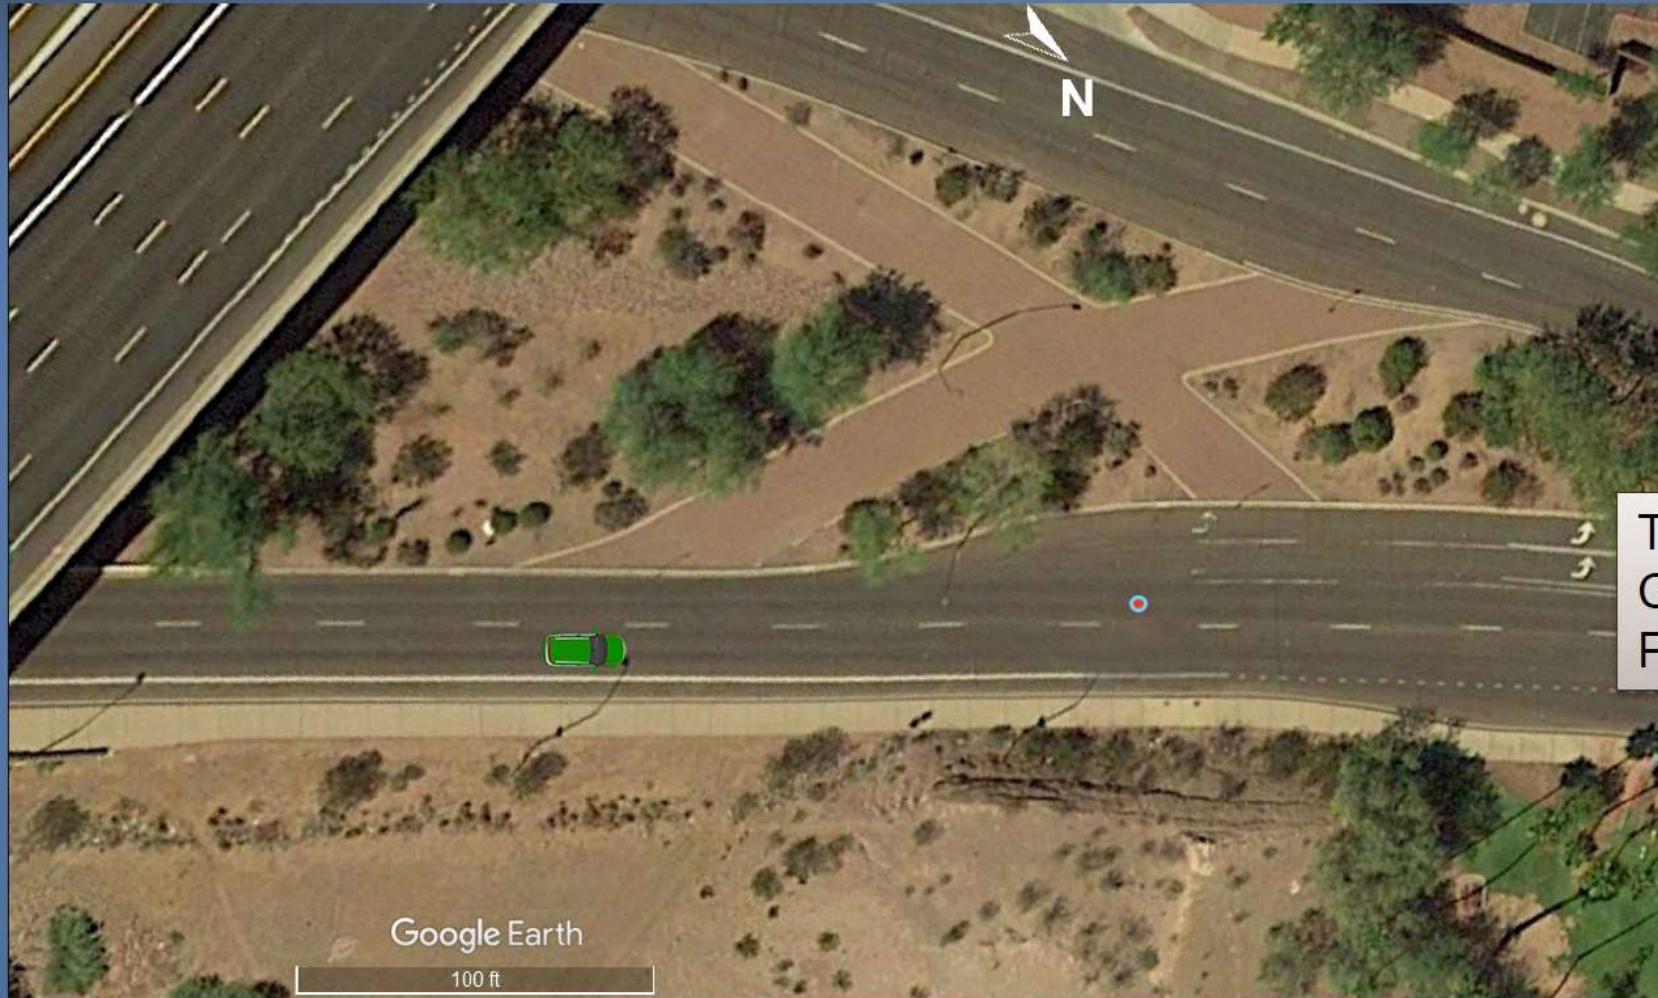
Perception and Motion During the Crash

Time to crash:	2.6 seconds
Classification:	Bicycle
Predicted path:	Static

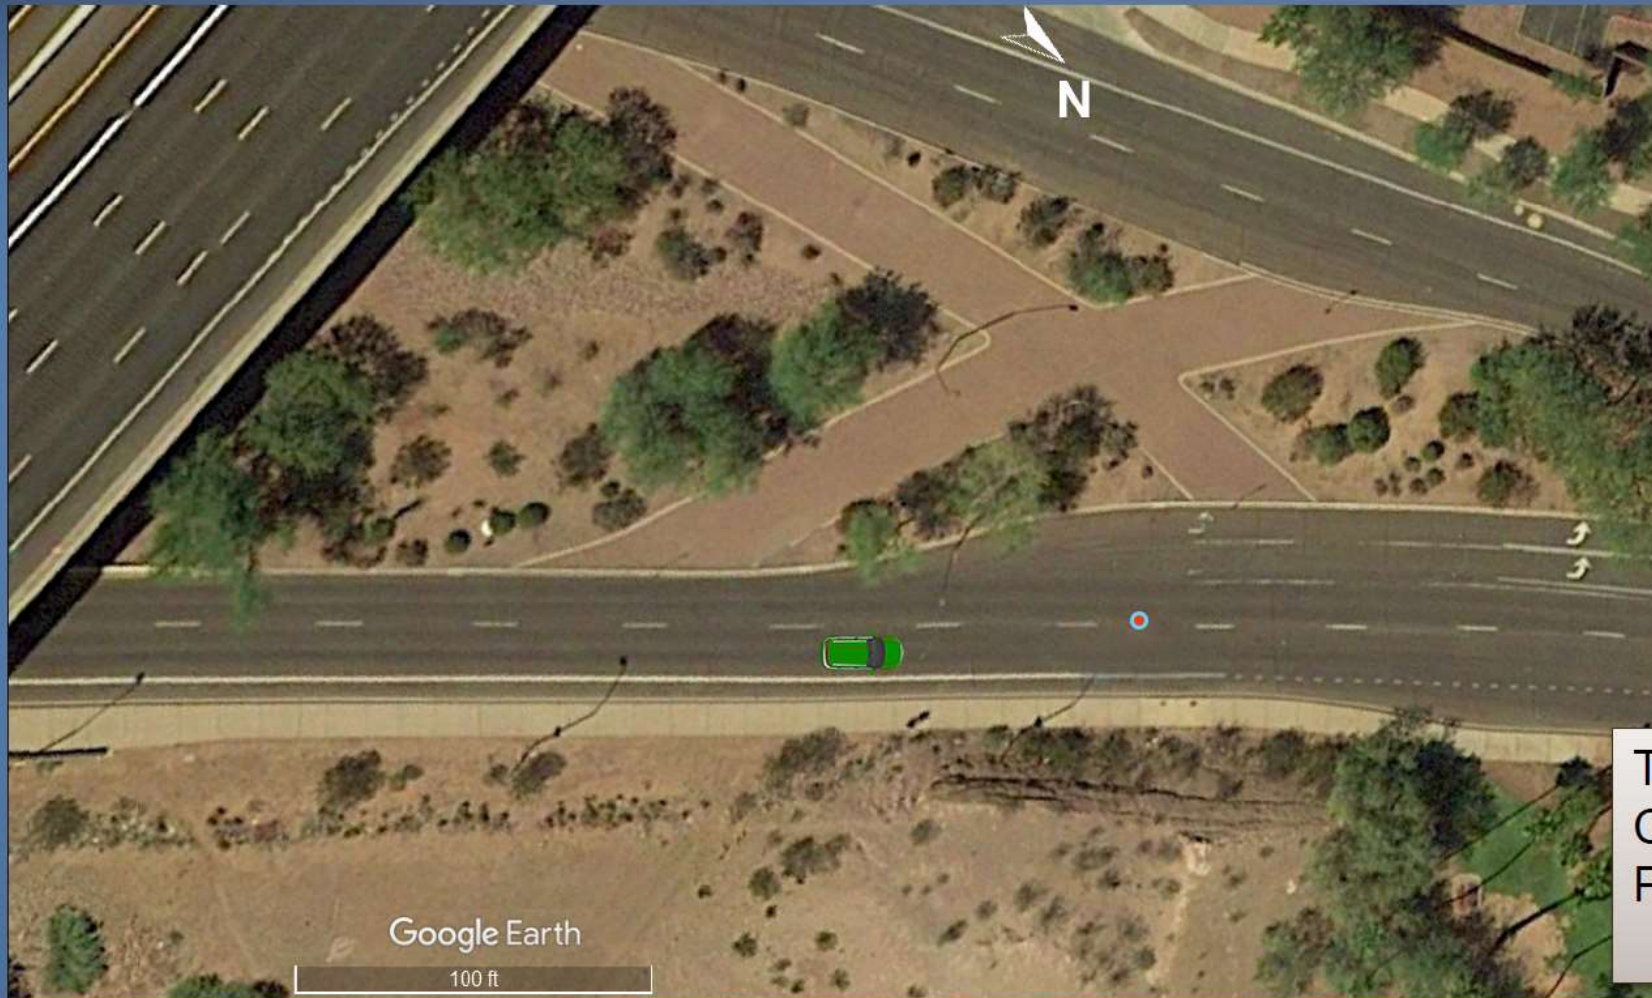
Perception and Motion During the Crash

Time to crash: 1.5 seconds
Classification: Other
Predicted path: Static, partially
on vehicle's path

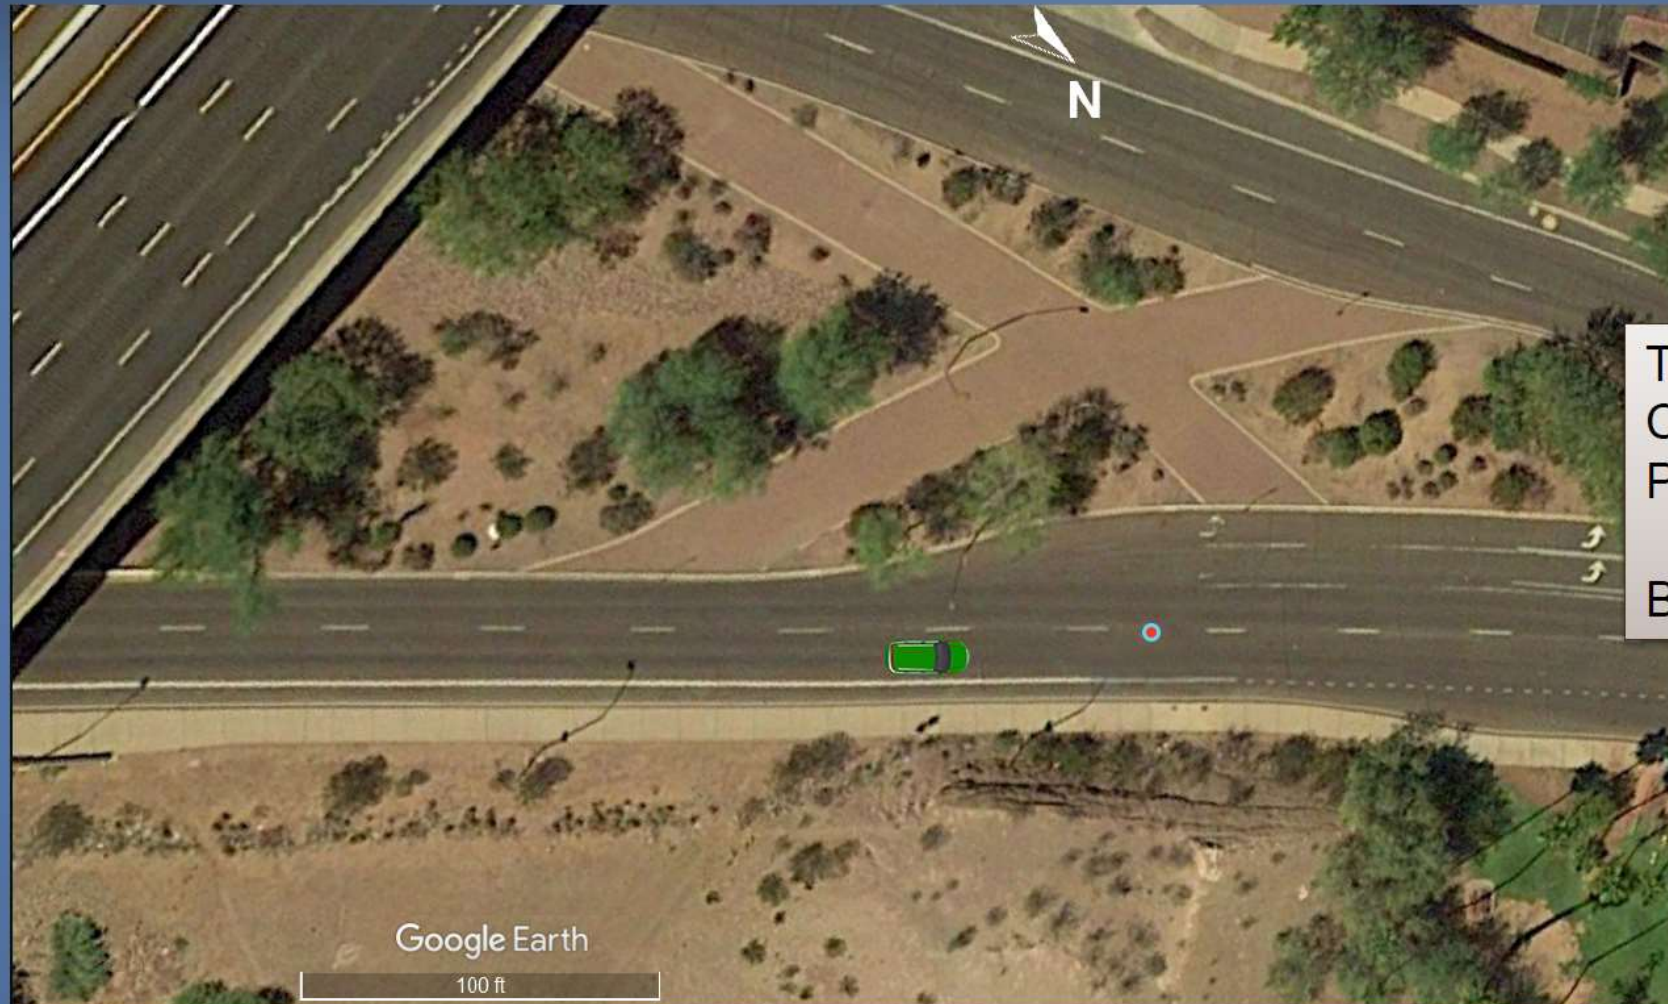
Perception and Motion During the Crash

Time to crash: 1.2 seconds
Classification: Bicycle
Predicted path: Fully on path
of the vehicle
Braking suppression begins

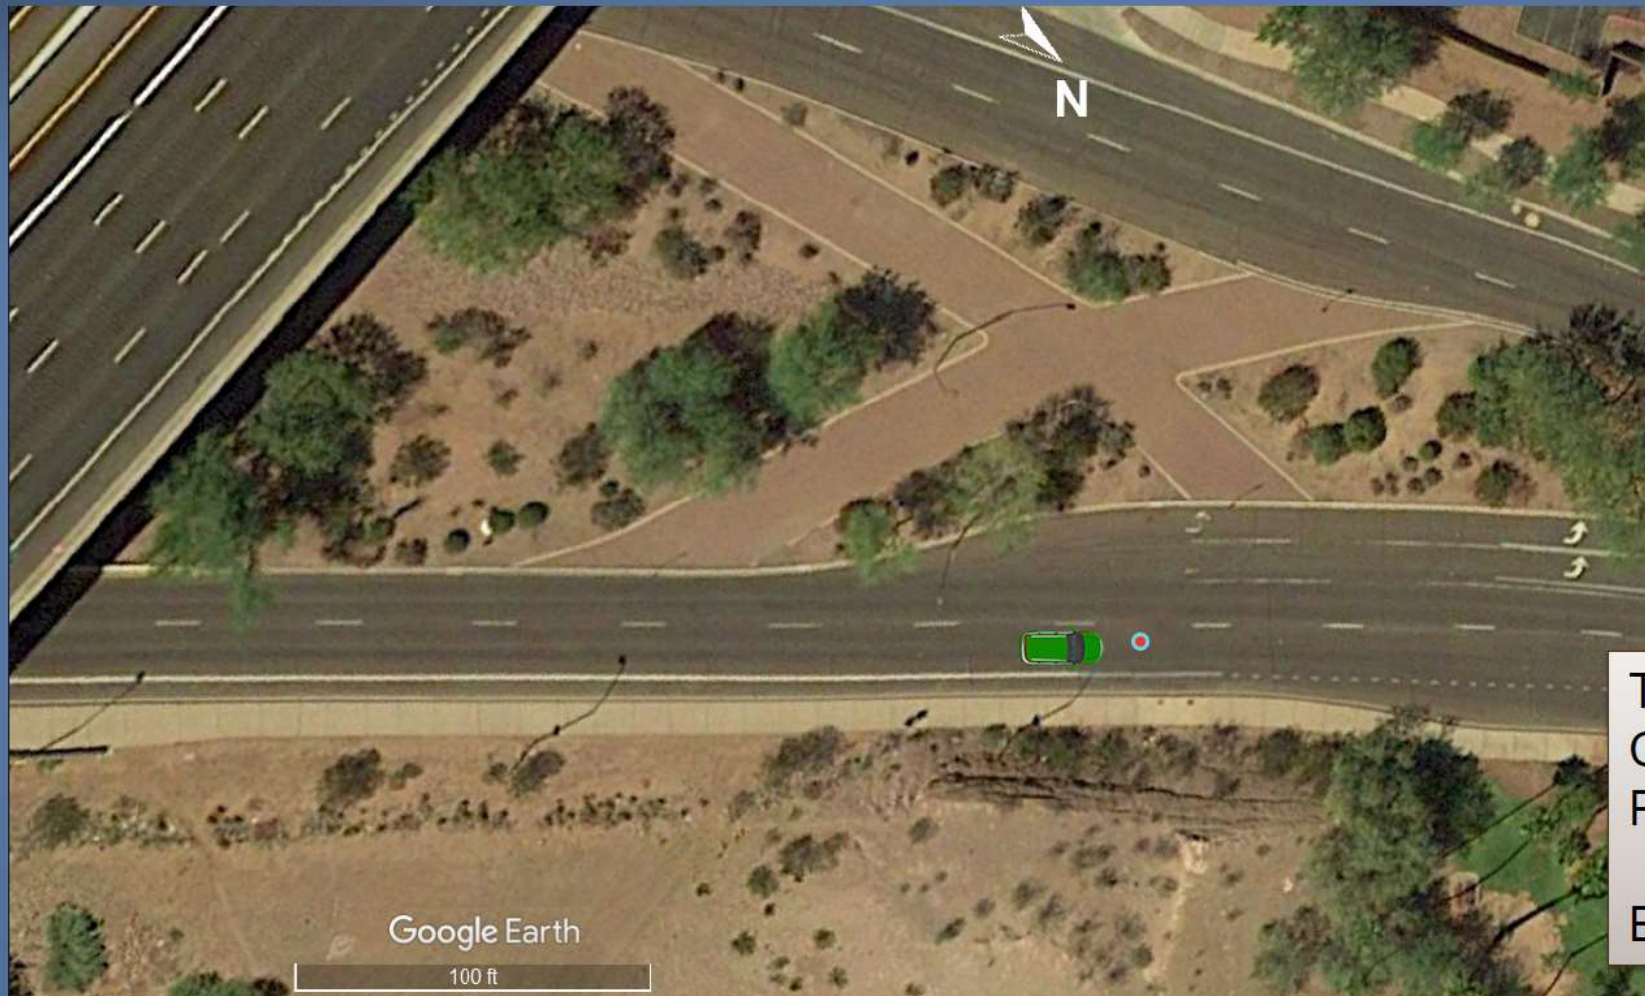
Perception and Motion During the Crash

Time to crash: 0.2 seconds
Classification: Bicycle
Predicted path: Fully on path
of the vehicle
Braking suppression ends

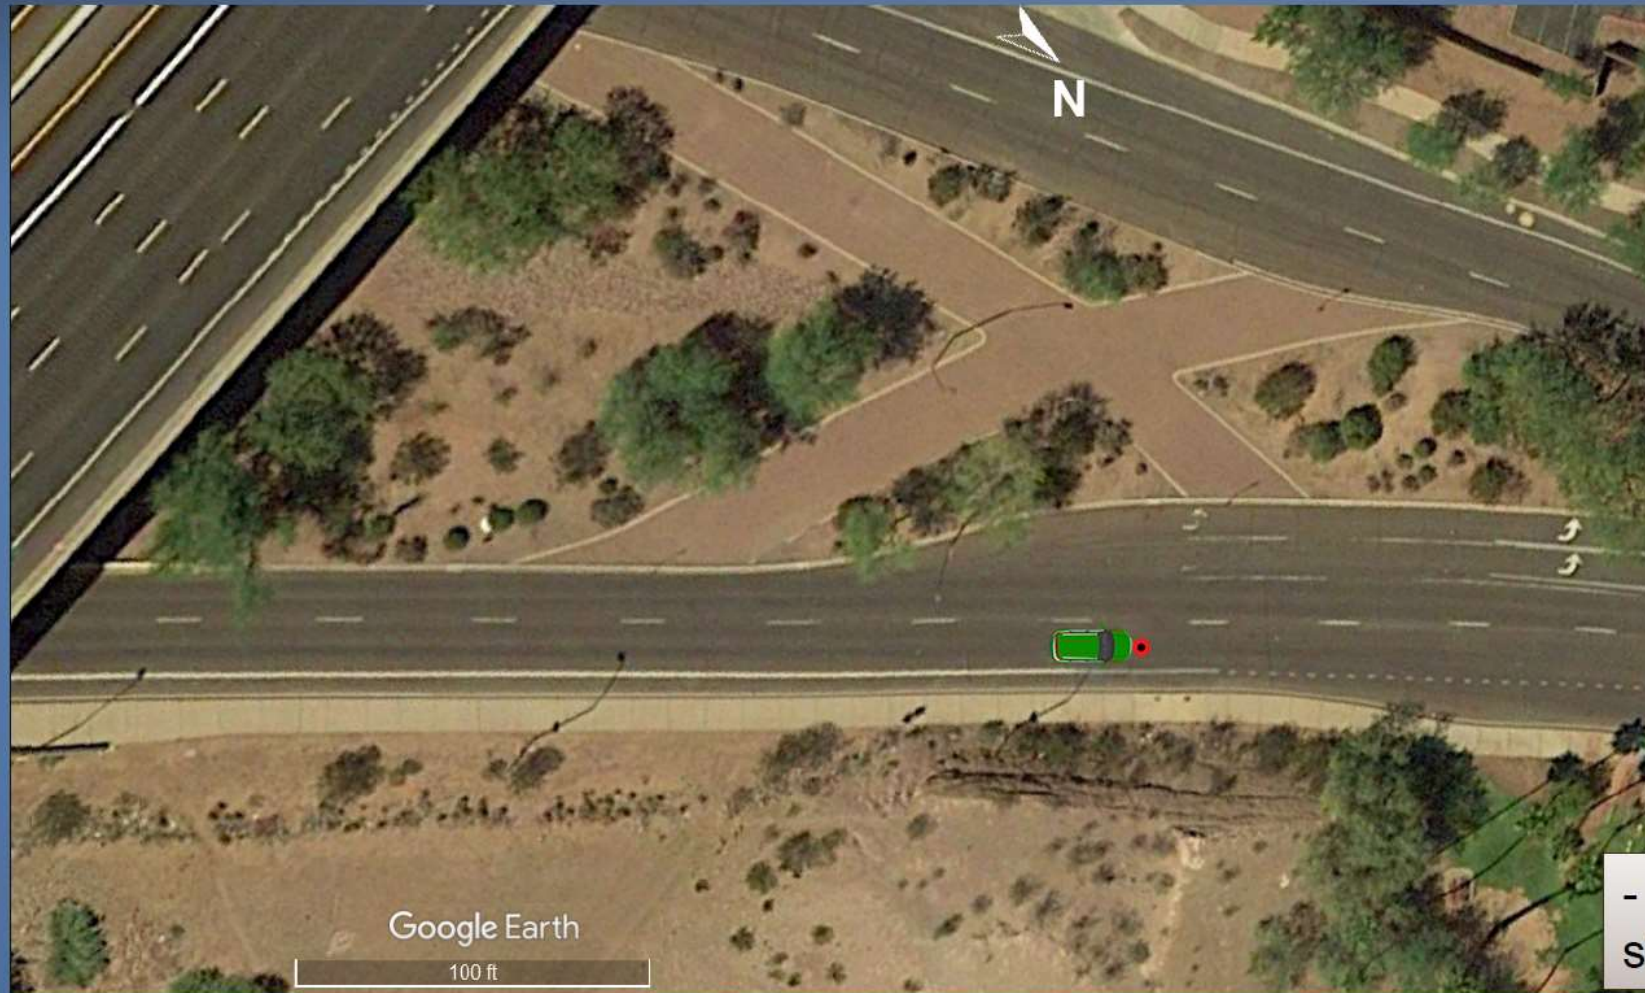
Perception and Motion During the Crash

- Vehicle operator initiated steering 20 msec before impact
